GENERAL AVIATION STRUCTURES DIRECTLY RESPONSIBLE FOR TRAUMA IN CRASH DECELERATIONS

John J. Swearingen, D.A.V.T.
FAA Civil Aeromedical Institute
P.O. Box 25082
Oklahoma City, Oklahoma 73125

January 1971

1. Report No. FAA-AM-71-3	2. Government Accession No.	3. Recipient's Catalog No.	
4. Title and Subtitle GENERAL AVIATION STRUCTURES DIRECTLY RESPONSIBLE FOR TRAUMA IN CRASH DECELERATIONS		5. Report Date January 1971

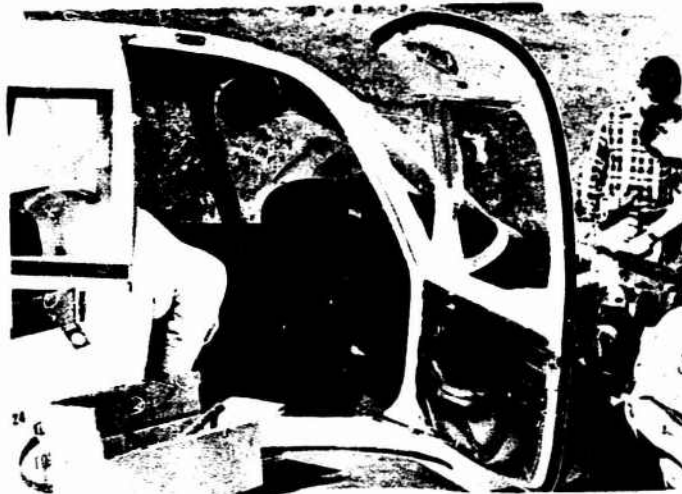
CASE 4-2

**D. General view of cabin;
interior.**

**E. Upper left
instrument
panel. No
damage
from head
impact.**

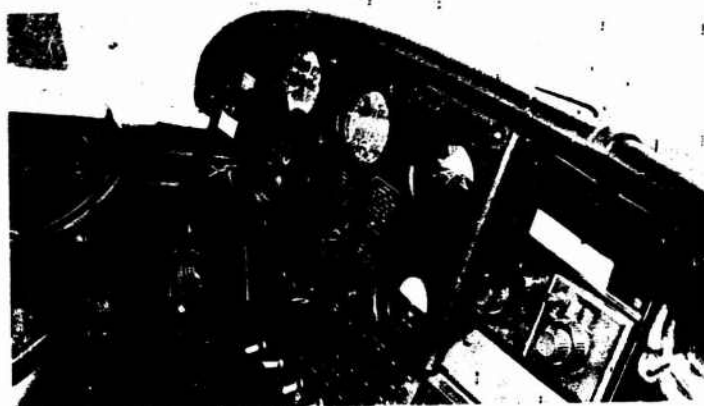
**F. Lower left instrument
panel. No damage from
knee impact.**

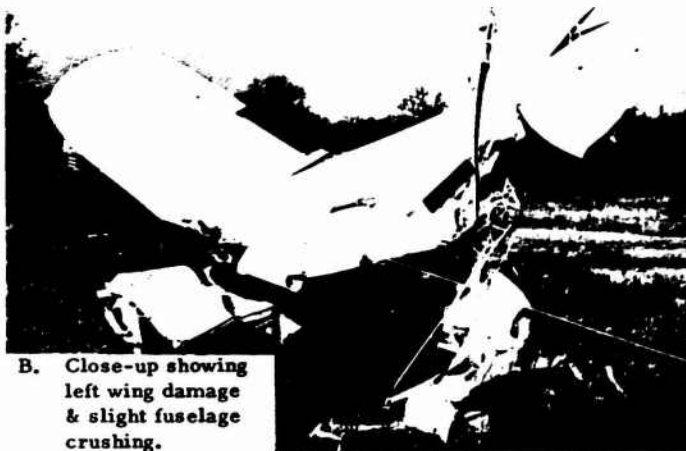
B. Close-up showing left wing damage & slight fuselage crushing.

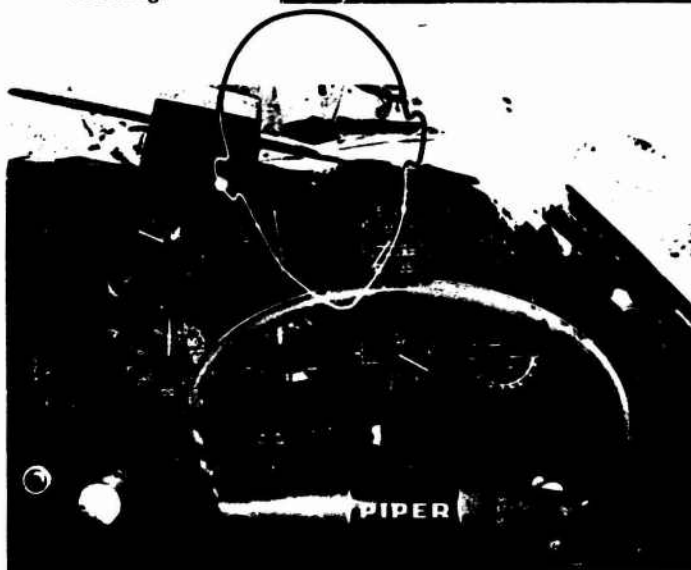
D. Dent at the top edge of instrument panel caused by copilot's head impact.

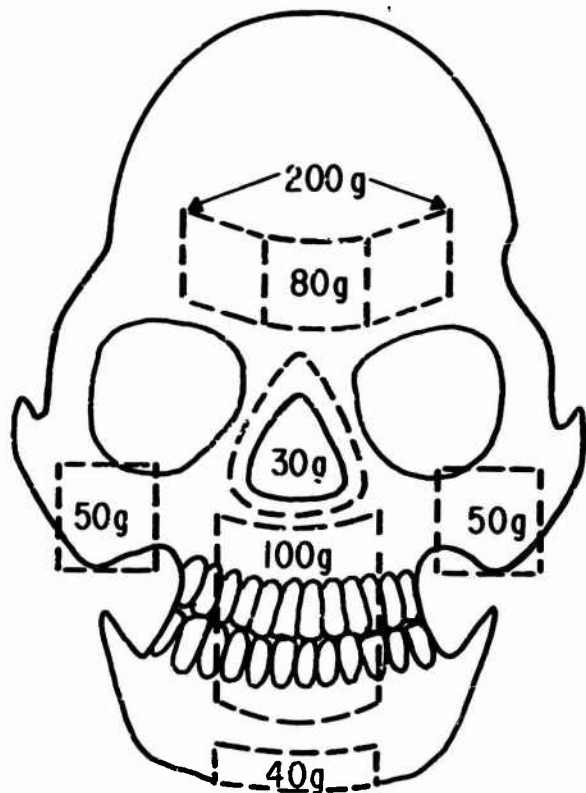
FIGURE 12. Tolerances of the human head to crash impact.

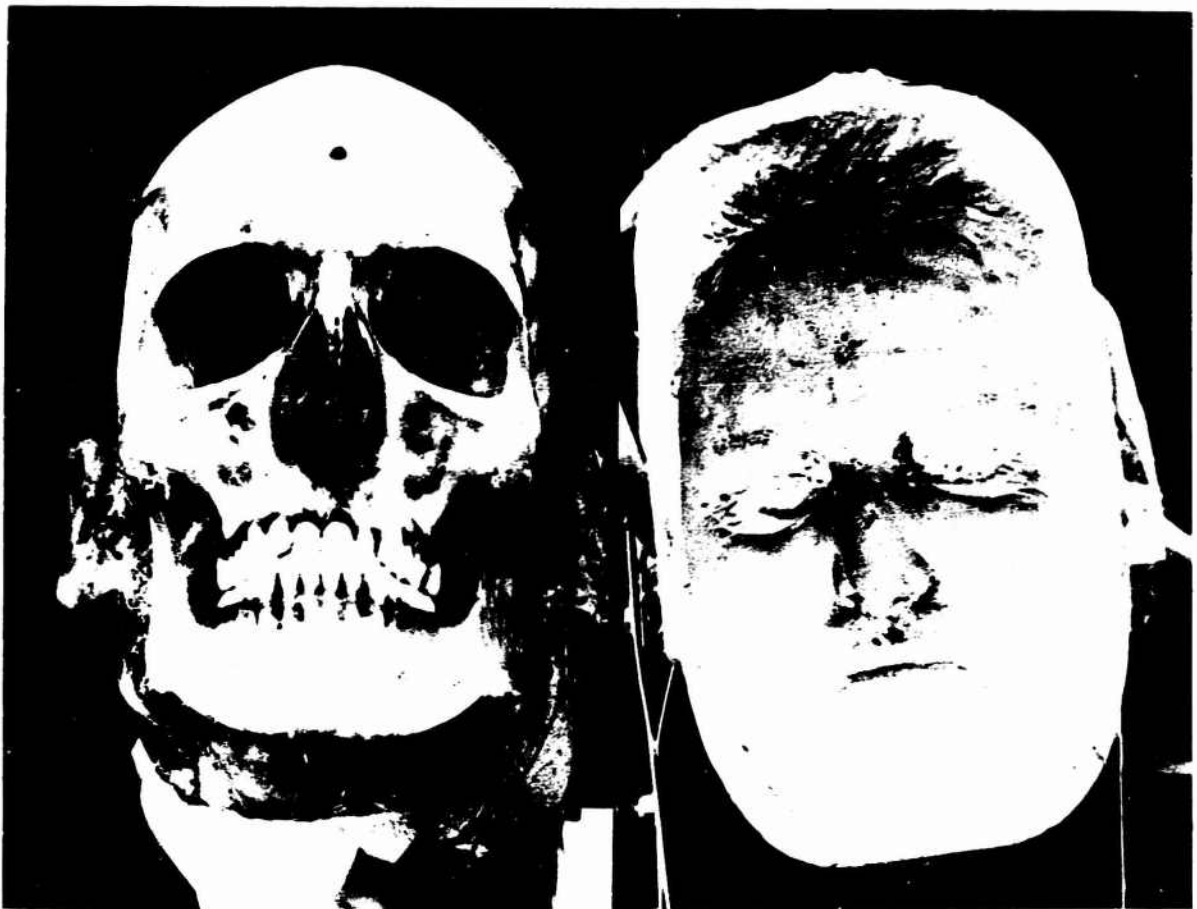
FIGURE 13. Full-face (maximum area) crash test exceed 300 "g" deceleration.

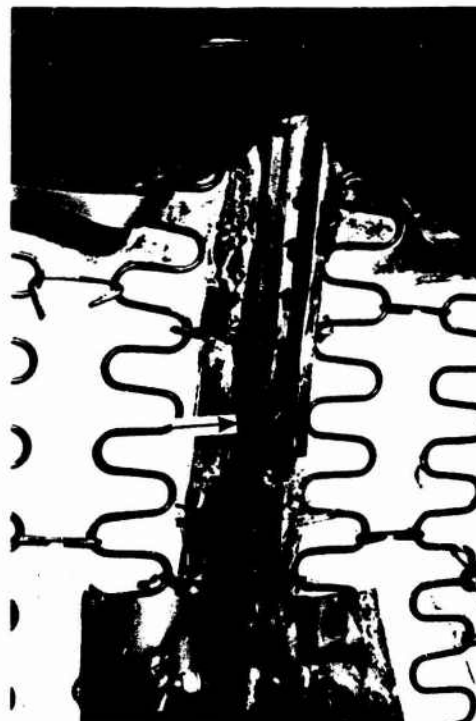
K. Adjustment pin & center tie-down flanges. Notice that the thin tie-down flanges are spread open, allowing the seat to leave the track.

L. Tie-down & adjustment structure on bottom of seat. The thin metal on either side of the adjustment holes bent & allowed seat to tear loose.

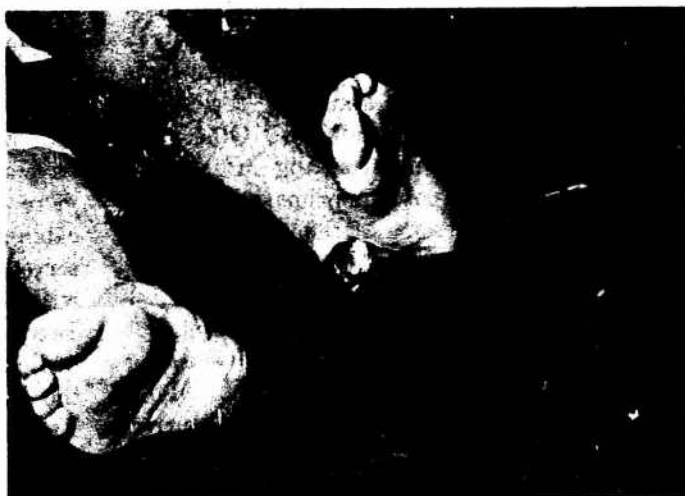
G. Typical ankle fracture from cross brace.

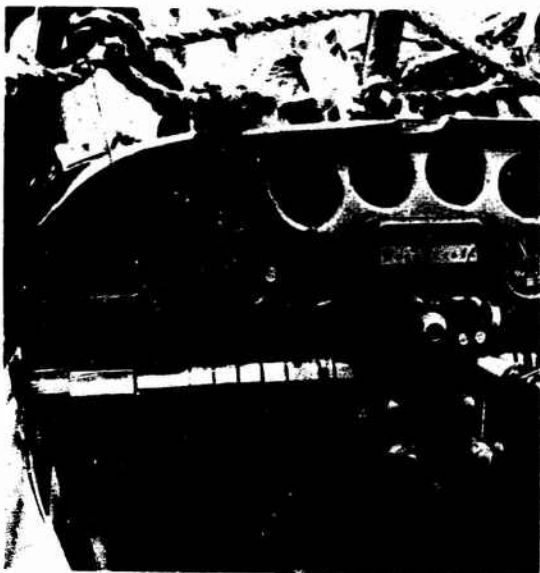
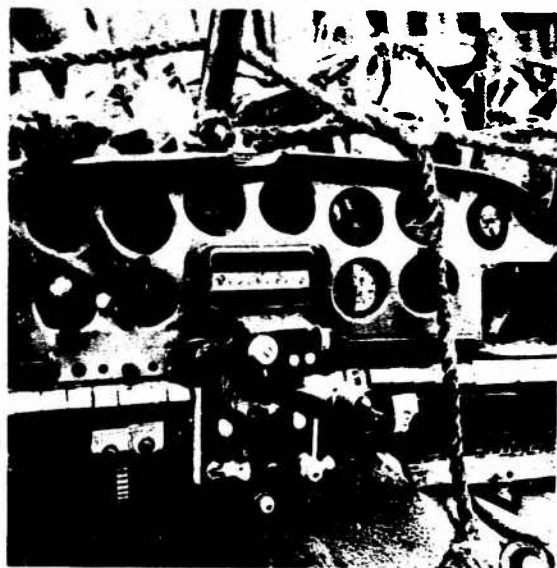
CASE 19-2

D, E & F Views of instrument panel
& cabin interior.

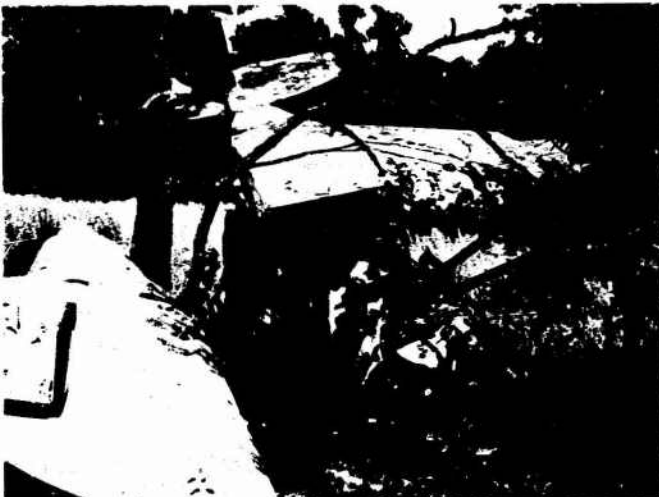
D. Front of aircraft showing complete separation of motor & instrument panel.

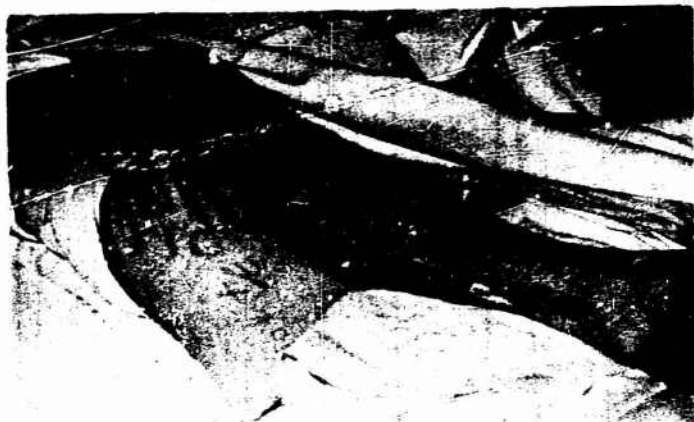
G. Copilot fractured tibia & fibula of right leg.

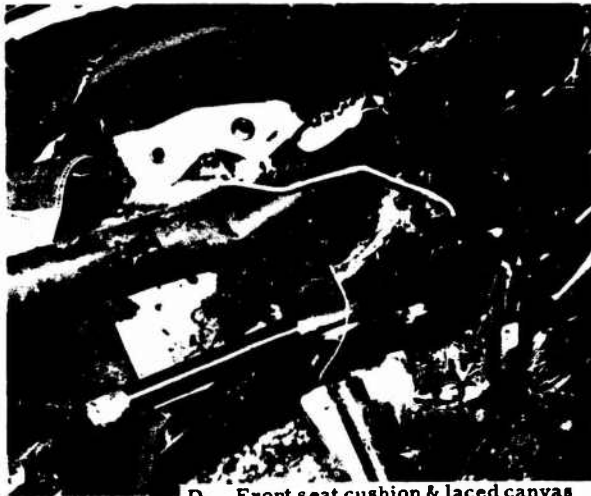
D. Front seat cushion & laced canvas removed to show tubular structure under seat that was responsible for vertebral fractures.

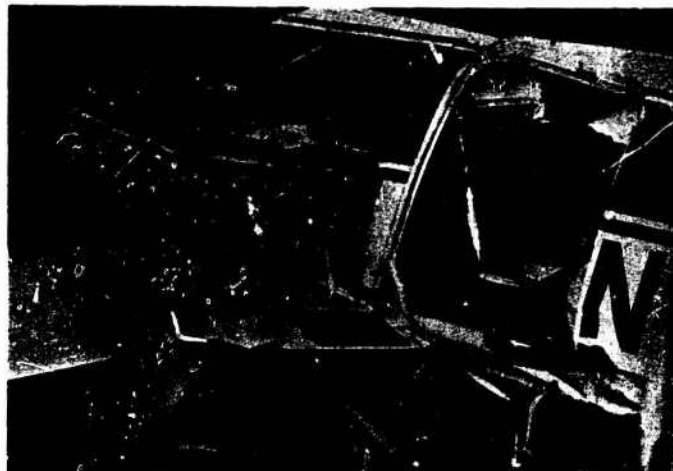
B. Motor is bent downward, landing gear pushed up into wings, instrument panel completely undamaged & rear passenger appears to be sitting flat on the ground.
